**US Army Corps  
of Engineers**

Construction Engineering  
Research Laboratory

USACERL TECHNICAL REPORT P-90/11  
April 1990

# **Five-Year Summary of Fort Irwin, CA, Family Housing Comparison Test: Operation and Maintenance Costs of Manufactured vs. Conventionally Built Units**

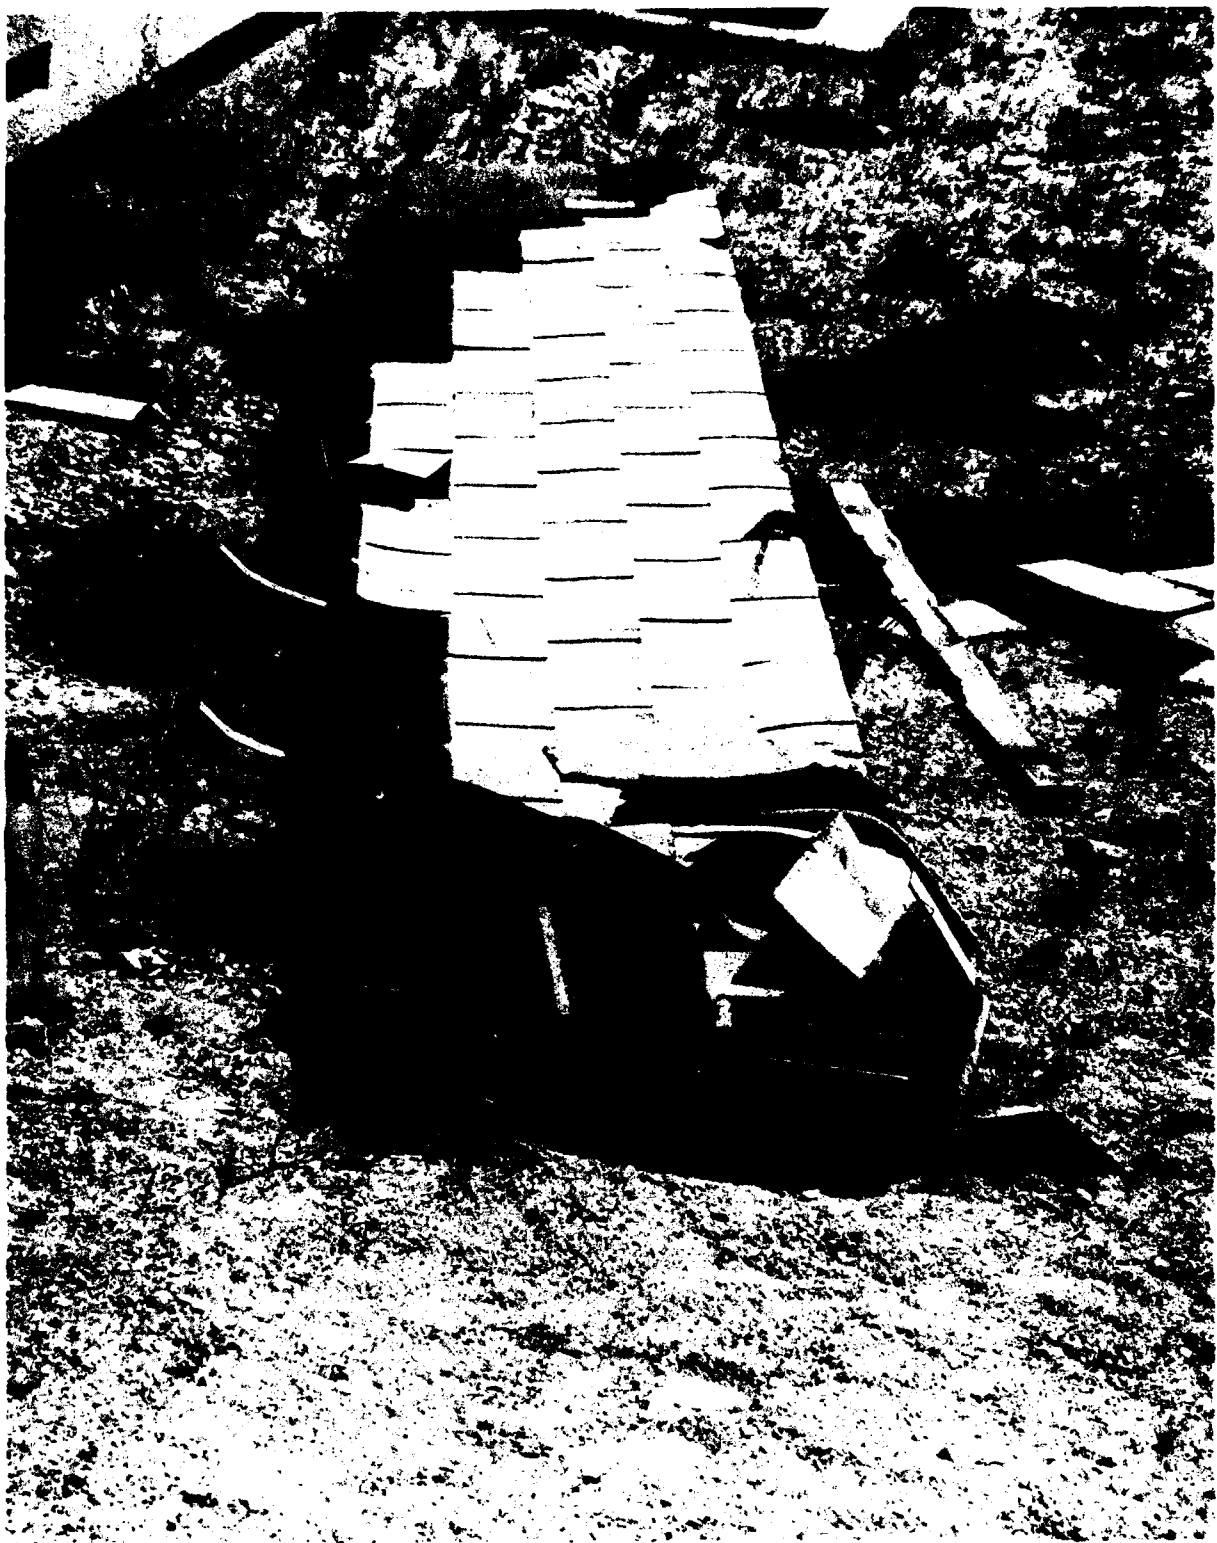
The major problem with these buildings was the eaves. These units were manufactured about 200 miles from Fort Irwin and transported by truck. Evidently, in order to meet highway width restrictions, the eaves could not be built on the modules. Rather, they were fastened to the roof with metal straps and folded onto the roof for transportation. At Fort Irwin, they were folded down. No permanent method of securing them to the building was used. As a result, in 1988, the straps began to deteriorate and one eave fell to the ground. Figures 9 through 12 show the problem. Those appearing in poor condition were temporarily fixed by putting up bracing. Then a contract was let to refasten all of them permanently. This cost is shown in Table 26 and is about \$1,673 per dwelling unit. This problem was not necessarily attributable to the manufactured housing process, but to poor design and quality assurance.

**Figure 10. Eave section which fell off a manufactured unit.**

- The "fold over" eaves method did not provide a permanent method of securing the eaves on site. This defect cost the government more than \$300,000 to correct.
- The use of inadequately fixed asphalt shingles, in combination with insufficiently pitched roofs, subjected roofing materials to damage from the high winds and heat of the desert environment.
- Gutters and downspouts, routinely affixed during construction, had little utility in the arid climate, and were subject to damage from high desert winds.

- The "fold over" eaves method must also provide a permanent method of securing the eaves on site.
- In a desert environment with high winds, buildings designed with a shallow roof pitch should not be constructed with asphalt shingles.
- No gutters or downspouts should be used in a desert environment, with the exception of small gutters over stairwells.
- Thermal pane windows should be used.
- Access panels should be provided for major plumbing junctures such as supply line "tees."
- Specifications for garage doors should be tightened to prevent the warping caused by substandard garage door materials experienced at Fort Irwin.
- Patio floors should be of either 6 in. or reinforced concrete. Quality assurance on patio and driveway concrete should be increased.
- Lawn sprinklers should be located so that they do not spray water on the air-conditioning condenser or the building walls.
